**Geomorphological Site Investigation Report**

**Date:** 17/02/06

Project / Job Reference: Woundell Beck Irish Bridge

Location: Ennerdale water River: Woundell Beck NGR: NY 13245 13771

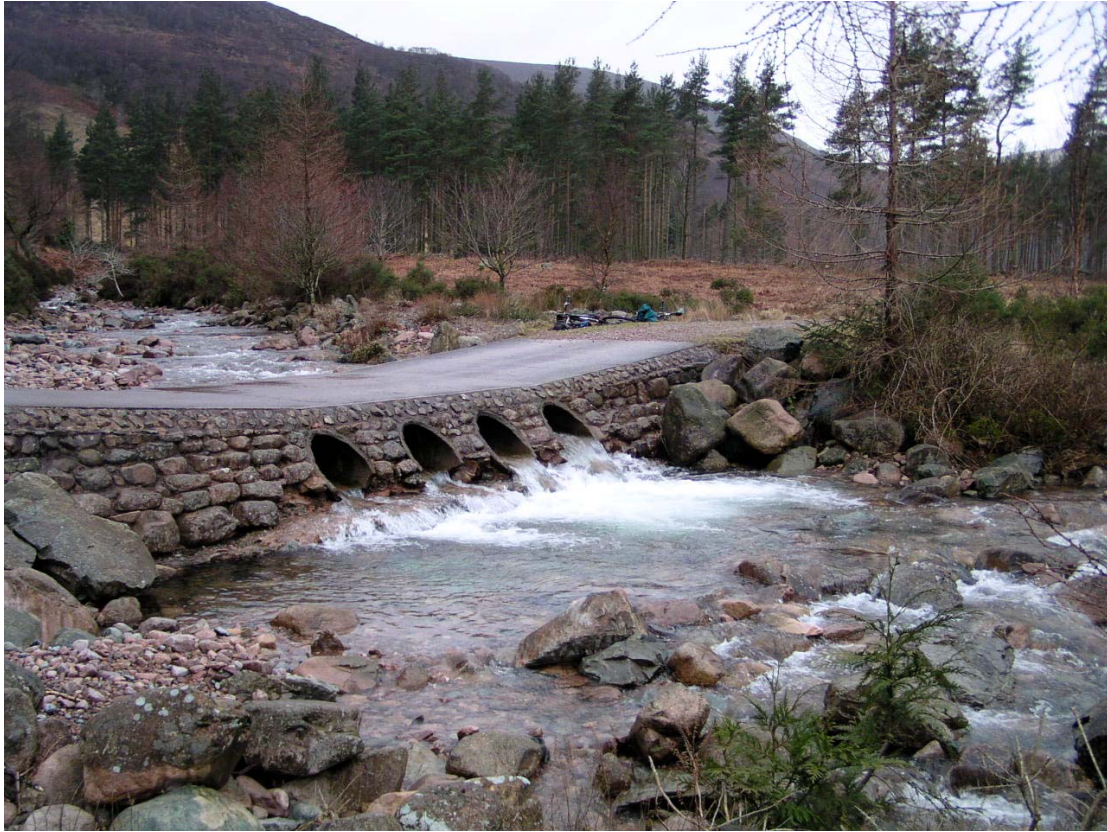
At the crossing, an Irish bridge has been installed. This consists of four 400 mm diameter concrete pipes overlain by rip-rap, faced with cemented blockstone and capped with concrete (see photos 1 and 2). Further over to the right bank is an additional bypass culvert, consisting of a 1m diameter plastic pipe. There is an erosion and blockage issue associated with the pipes, which requires the Forestry Commission to clear gravel from the upstream side of the crossing, and reinstate the material of the track at numerous intervals over an average year. There is a significant scour pool downstream of the crossing, presumably a result of the flow overtopping the structure once the pipes are blocked. The bridge design would apparently have been to allow sediment and low flows to pass through the culvert pipes and for higher flows to spill over the bridge top. This is not happening for the following reasons :

Photo 1) Irish bridge, downstream looking upstream from NY13257 13778

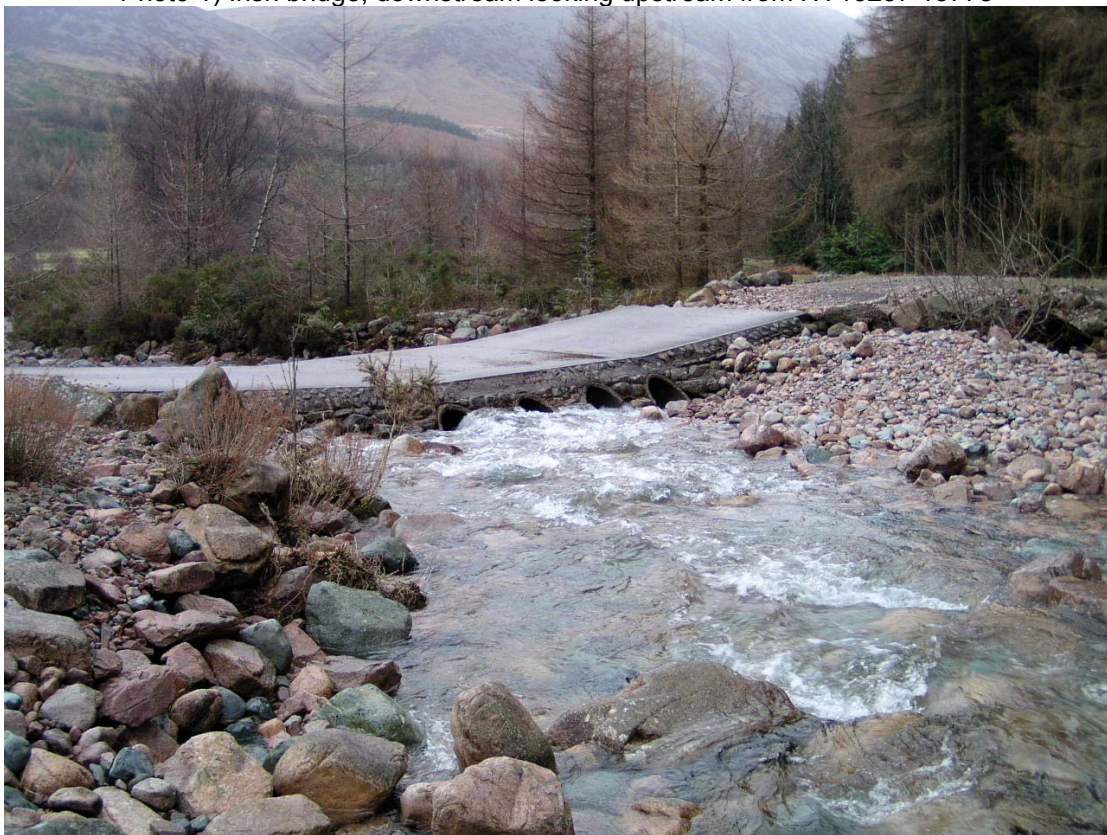
Photo 2) Irish Bridge, Photo from NY13233 13762, downstream.

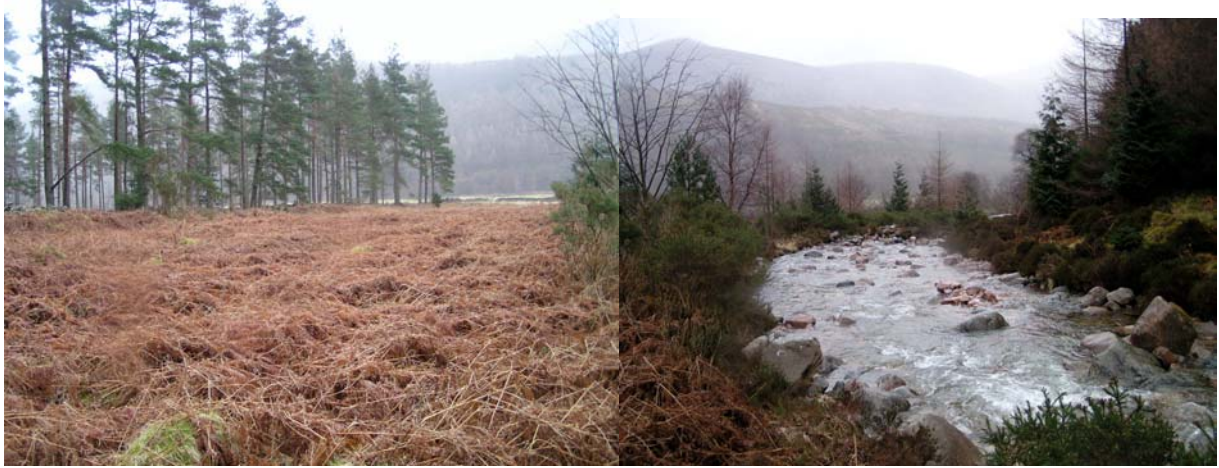
Photo 3) alternative upstream crossing site, photo form NY 13142 13698, downstream.

For both options, moving the crossing point is a possibility. Upstream of the site by 60 m the right bank shelves up to form a terrace, and the river is more constrained on the right bank, but not the left. An Irish bridge at this site may result in flow being forced to the left and bypass the structure. There are paleo channel and relic flood deposits in this area. This might suite a bridge option though as the right bank would not require raising. It is not known whether a bridge would fit in with the ‘Wild Ennerdale’ vision.

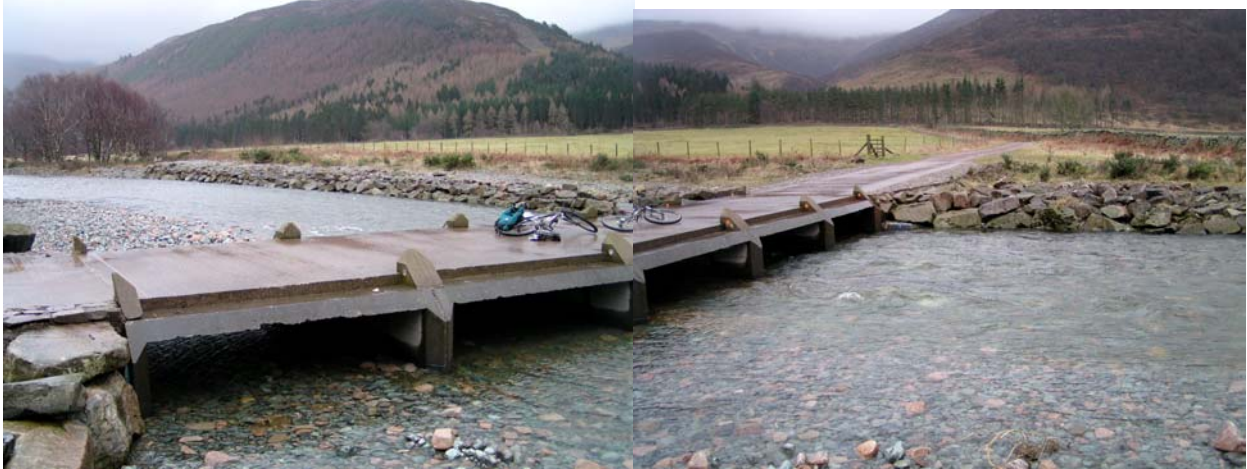
Photo 4) Irish bridge on Liza. Photo from NY 13078 14237, upstream.

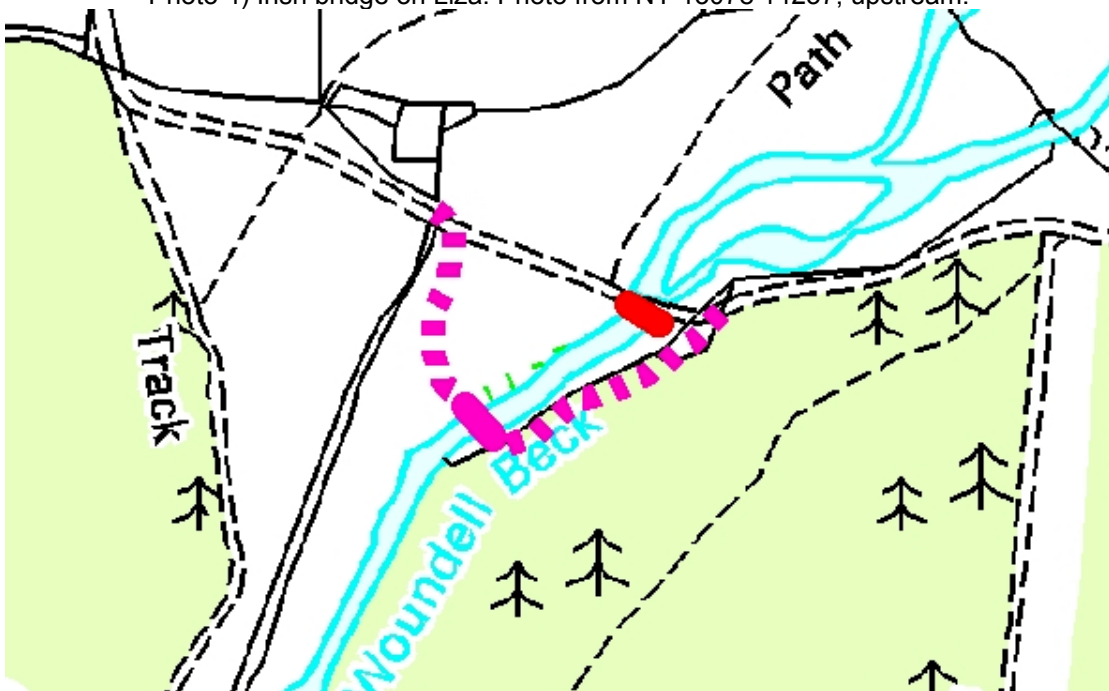
Figure 1) Suggested 'perpendicular' crossing point in red, and upstream alternative in pink.

The first option would be to use a design approach similar to what was attempted, but would attempt to overcome the capacity issue. This could be achieved by realigning the crossing so that it crossed perpendicular to the river (rather than skewed), and to utilise culvert box sections that have a high aspect ratio (i.e. high x-sectional area per supporting material area). These have been successfully installed downstream on the Liza (see photo 4). This crossing is a definite success, judged from: the lack of sediment build up on the left bank (there is some build up but this relates more to the bend than the structure); the conveyance of natural sediments through the structure, as evident from the distribution of bed sediment up and downstream, and the lack of lateral scour or flow diversion, due to the blockstone bank protection, and due to it having a minimal cross section profile; there was also absence of a scour pool downstream, partly due to it having a low deck level and minimum cross section profile, and downstream bed scour protection. It should be noted that the sediment  $D_{50}$  at this location is large cobbles (100 mm), and not the large boulders seen on Woundell Brook – which is the reason why the culvert deck can be lower. On Woundell beck, the height of the bottom of the deck above ‘natural’ bed level would have to be at least 450 mm. The concrete deck of such a solution would have to go further laterally up the right hand bank to avoid the existing track washout problem.

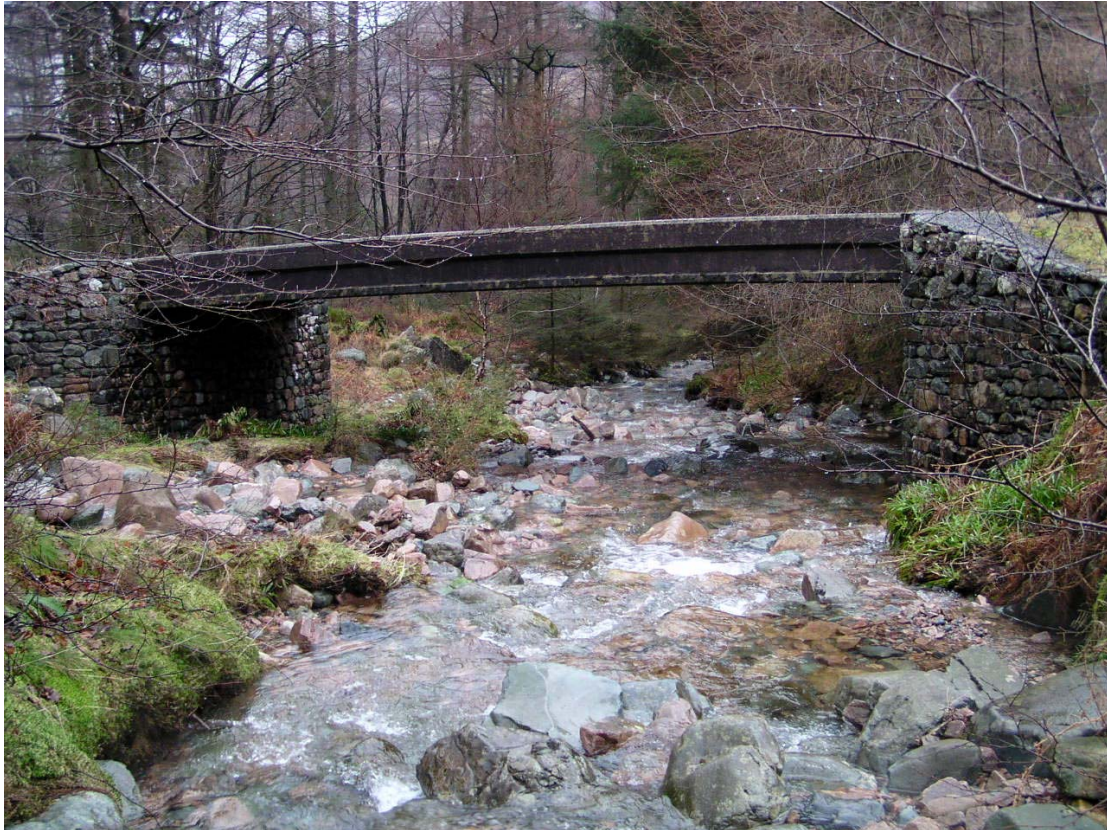
Photo 5) View of river channel and floodplain morphology, showing a transport reach with scattered deposition. Photo from NY 56831 03334, upstream.

The second option is to get the bridge deck high above the bed to allow sediment and flow conveyance (see photo 5). This would require building up of the approach heights of the road and would require stone pier foundations. The bridge span on photo 5 is 10 m – ideally this would be slightly wider on the Woundell as the natural channel is around 12 metres wide.
